Application Note. Pass-by Measurements.

2D Measurements – Train Pass-by Train curve squealing noise

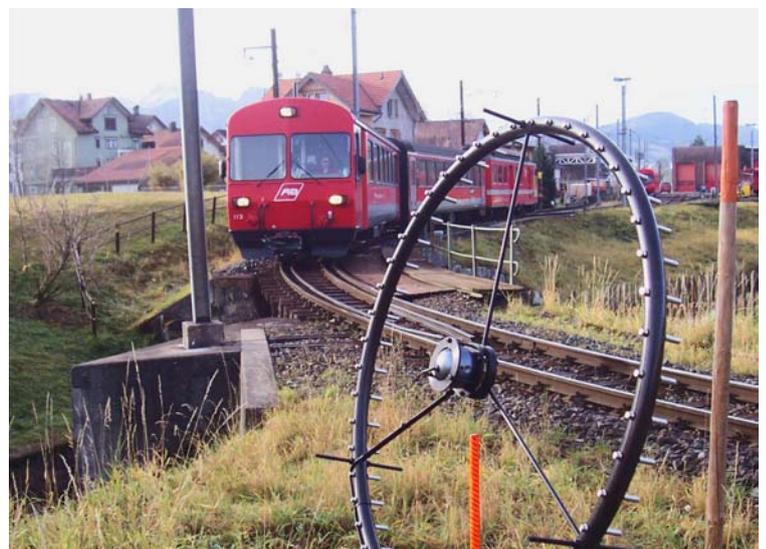
Fig. 8 Appenzeller Train passing by at measurement set up of the Acoustic Camera

Another measurement should clarify the practicability of the retrofit of wheel noise absorbers for vehicles of the Appenzeller Bahnen on a special line (Fig. 8). For this purpose one train with and another one without a wheel noise absorber was available.
