Application Note. Interior Noise Measurements.

3D Measurements – Airplane Cavity Cabin mapping of a Cessna C 172

This application example demonstrates the application of the Acoustic Camera for the analysis of flight noise in the cavity of an airplane. For this purpose a one-propeller Cessna C 172 has been analyzed during flight and landing. Besides different flight modes several targeted excitations inside the cabin have been measured and mapped.

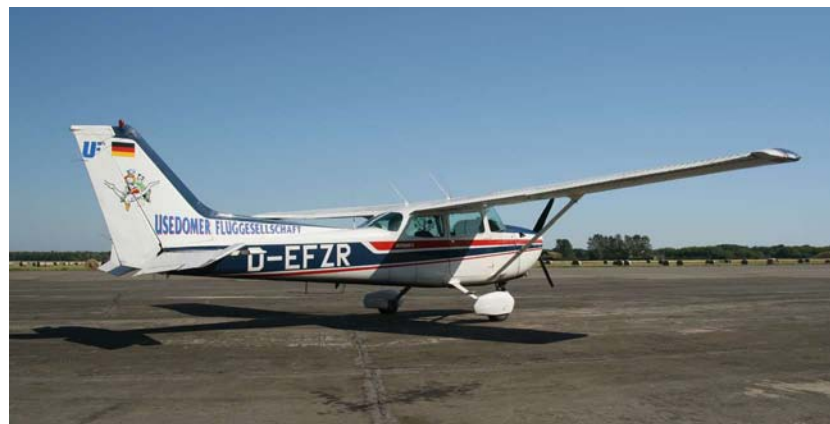
Fig. 1 Measuring object Cessna C 172

Fig. 2 System set-up

Fig. 3 Array position inside cavity

The set up of the Acoustic Camera inside the airplane took about 10 minutes. After another 5 minutes for the connection of the mobile power supply and the fitting of the array position into the 3D CAD model of the airplane the system was ready to go.
